The State of the Streams

A Summary of 2022

Ennis, Montana – June 1st, 2023

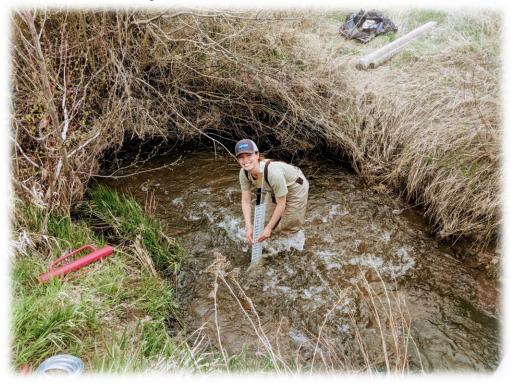
*2022 BSWC Member installing staff gauge (Raeya Gordon)

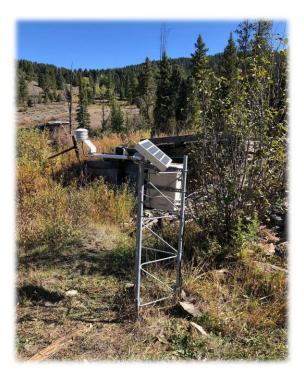
*JCP-SSR data logger monitoring station

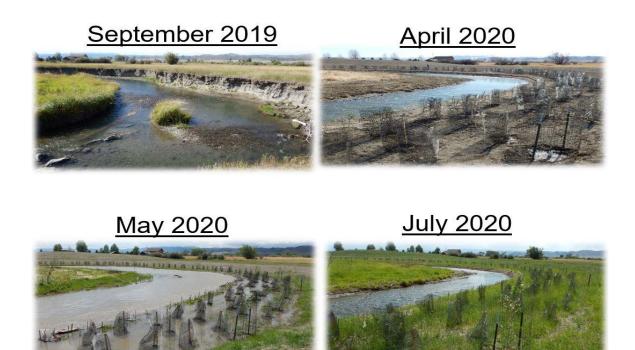
*Large bend on part of Lower Jack Creek Restoration. Note the spillover of high water onto banks that soaked into the riparian area and provided water for soil recharge and establishing plants during the project's first year.

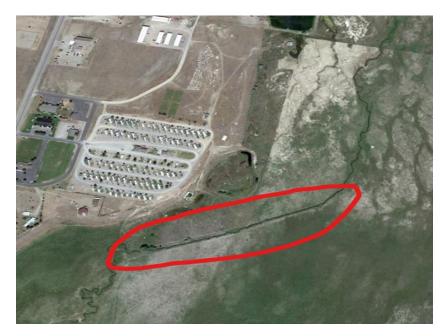
*Satellite imagery clearly indicates the channelized section of this valuable tributary stream.
