MADISON WATERSHED PLAN

A GUIDE TO WATER QUALITY
AND WATERSHED HEALTH
IMPROVEMENTS IN THE
MADISON VALLEY

Published: March 2024

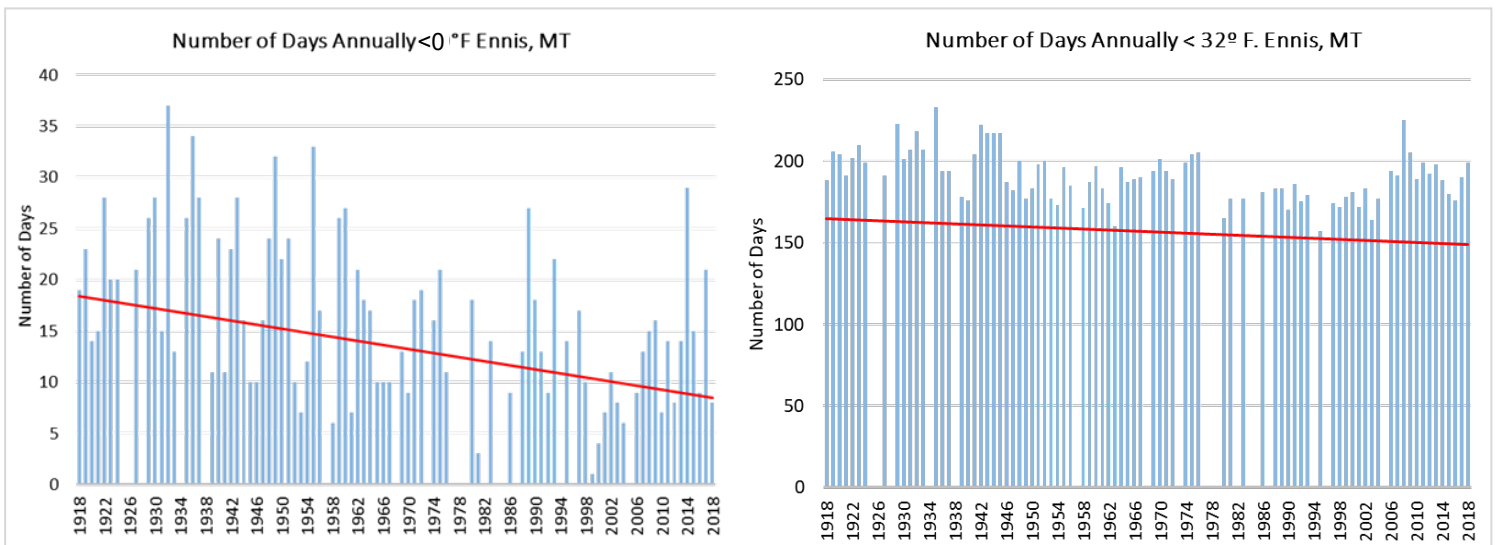
Figure 5. Number of days below 0°F and 32°F Annually for Ennis, MT from 1918-2018. Source: NOAA

Temperatures in the Madison Valley consist of long periods below freezing, with a short growing season. According to the 1965 Water Resources Survey, the growing season for Ennis, MT is 101 days long. Since that time, however, the number of frost-free days has increased, while the number of days above 90°F has also increased (Figure 4). The increasing temperatures have strong implications for water availability as well as agricultural production. Fewer sub-zero days throughout the year are changing the accumulation of snowpack, which can affect the availability of water for irrigation and instream flows. The increased number of frost-free days have the potential to increase agricultural productivity. However, there is also an increase in evapotranspiration from an increased number of days in summer that reach temperatures above 90°F. Figure 4 shows the number of days each year in Ennis with highs above 90°F, while Figure 5 shows the number of days each year where temperatures dropped below 0°F and 32°F respectively.

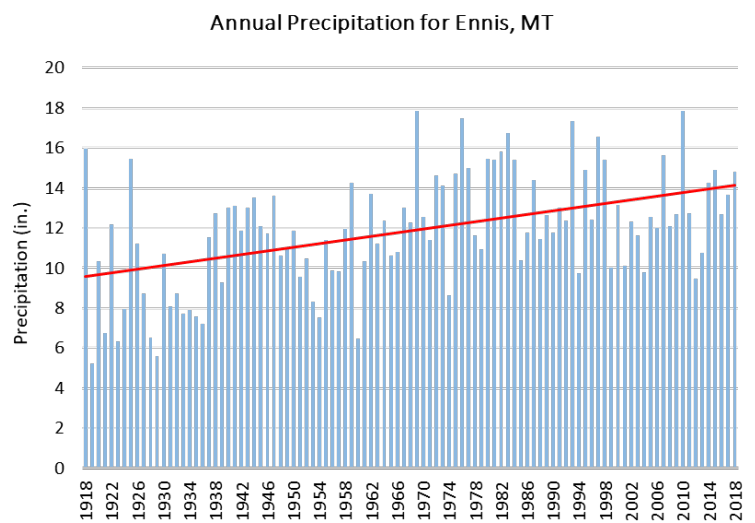
Figure 6. Annual Precipitation in Ennis, MT from 1918-2018. Source: NOAA

Precipitation across the Madison Watershed varies considerably. Winter snowpack contributes large amounts of moisture in the Madison, Tobacco Root, and Gravelly Mountain Ranges, while the valley bottoms typically receive much less precipitation overall. The 1965 Water Resources Survey documented the average annual precipitation for Ennis as 11.14 in/year. However, the most recent 30-year (1988-2018) mean precipitation for Ennis is now up to 12.56 in/year. The overall trend for the past 100 years shows a slight increase in precipitation throughout parts of

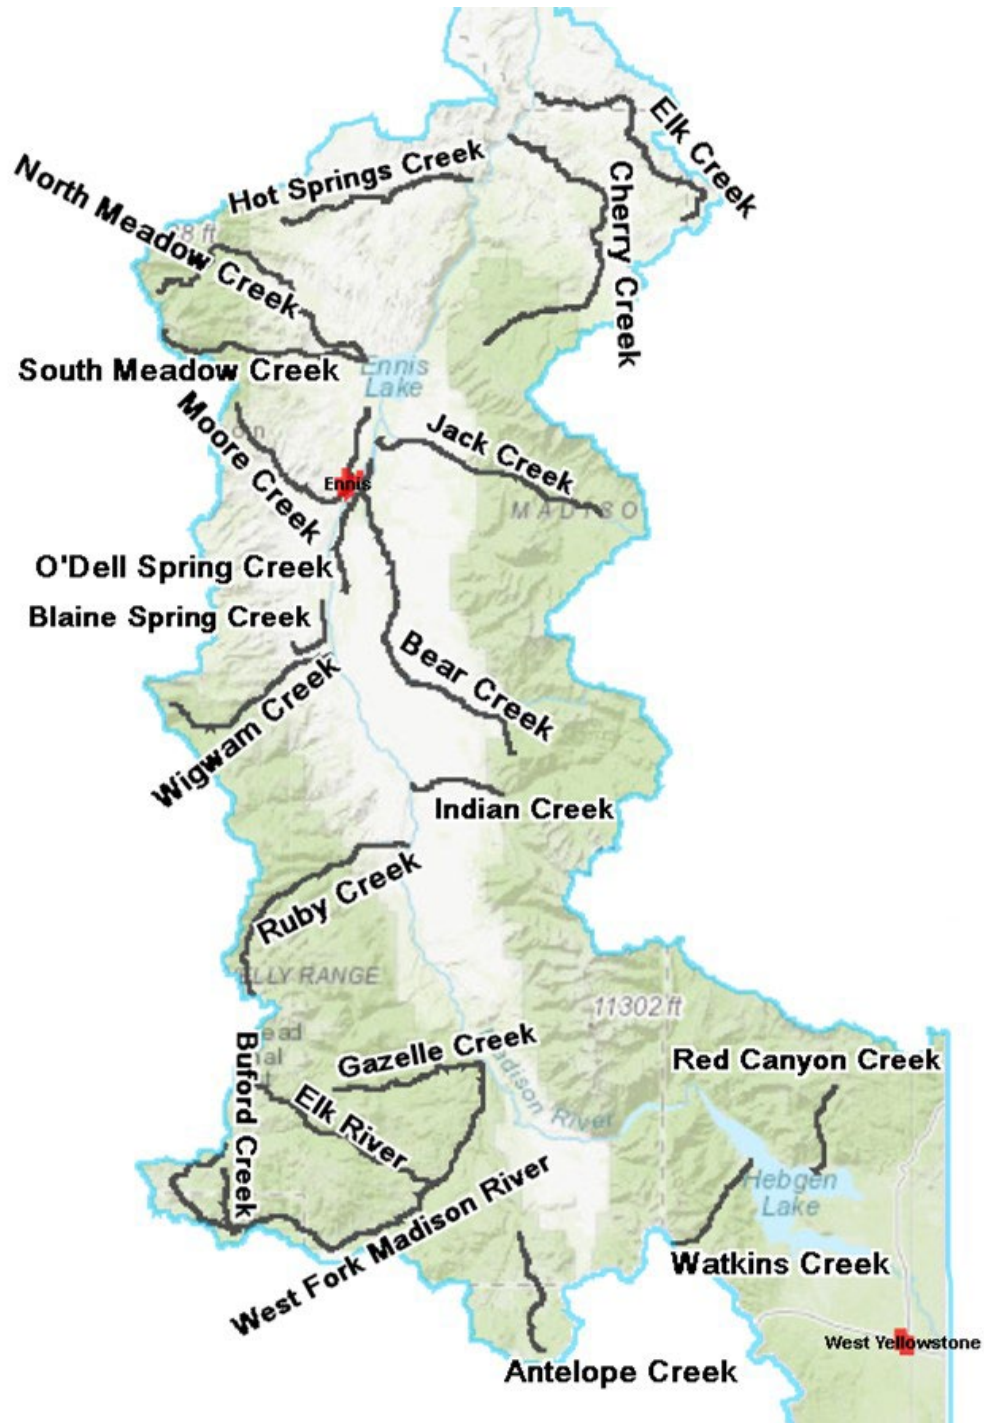
Figure 16. Map of Impaired streams in the Madison Watershed. Source: MT DEQ. 2020. Madison Watershed Stream Summaries. Helena, MT: Montana Dept. of Environmental Quality.

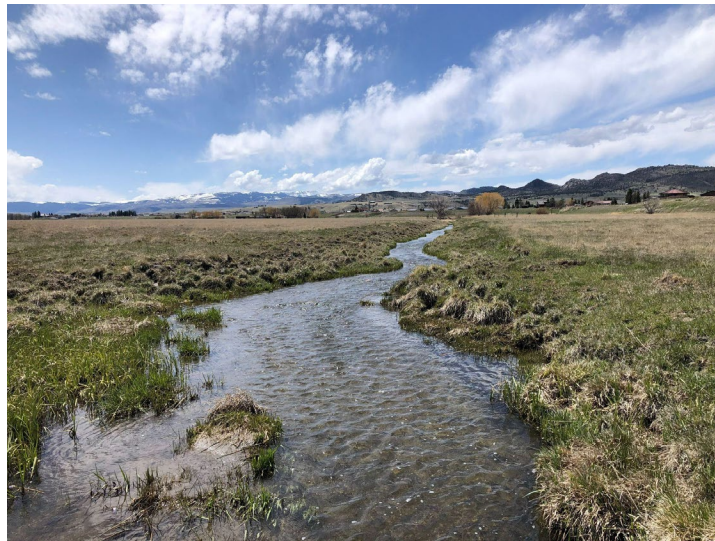
Lower Moore Creek restoration site, pre-restoration photo monitoring. May 11, 2022

Importantly, with a partnership between Montana Fish, Wildlife and Parks, the Madison Conservation District, Natural Resources Conservation Service, multiple NGOs, and multiple landowners, there have been conservation successes and significant steps undertaken for future restoration work on the creek, including channel restoration and the installation of nutrient abatement wetlands.

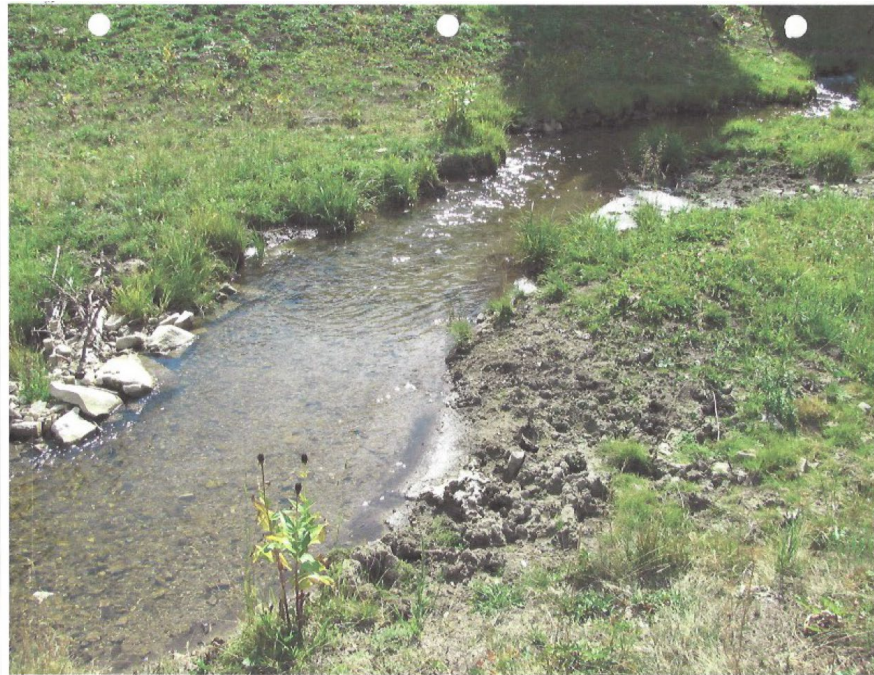
Upper Wigwam Creek restoration site, pre-restoration. Approximately 2005

Wigwam creek is a spring fed creek originating high in the Gravelly Mountain Range. It runs through a patchwork of USFS and private working lands. It is listed for sediment impairment due to the designated use as important aquatic habitat. Wigwam Creek does not meet the target width to depth ratio to move fine sediment. This combined with excessive fine sediment due to riparian grazing creates sedimentation/siltation issues despite generally healthy channel form and habitat quality. In 2005-2008 there was a large collaborative effort to restore a portion of upper Wigwam creek. Partners included the Madison River Foundation, MCD, USFS, and the Bar 7 Ranch. A low-tech process-based restoration (LTPBR) approach was taken, using wooden stakes, rocks, and mud to create point bars and encourage increased meander in the stream and slow water velocity. Over time, these point bars trapped sediment and diversified the stream structure. The stream was also fenced off to create a riparian pasture and protect vegetation regeneration. Looking forward, there are opportunities for restoration on Wigwam creek using similar LTPBR methods to trap sediment, encourage meandering, and improve water quality over time, along with active channel restoration in severely over widened and degraded areas. The prior restoration on the upper section of Wigwam Creek provides a good model of the potential improvements that could be made on lower sections facing similar challenges.

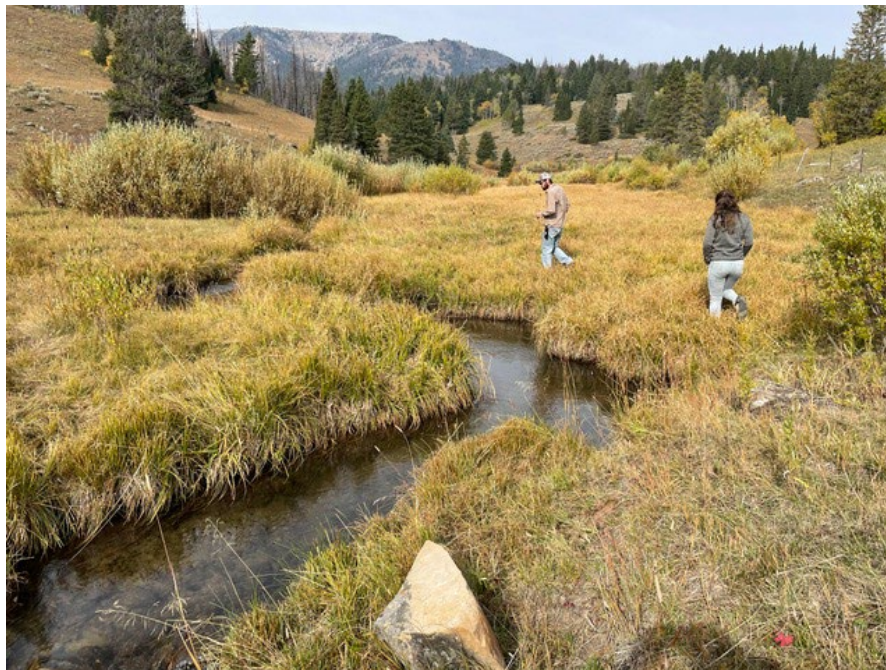
Upper Wigwam Creek restoration sites, post-restoration. September 23, 2021

A section of Wigwam Creek located immediately upstream of the FS Road 290 bridge crossing was severely degraded because of historic livestock overuse and was restored between 2005 and 2010 by USFS Fisheries staff and volunteer partners using bioengineering techniques along with native materials. Using harvested rock and onsite wood, several pools and baffle structures were installed to improve stream function and riparian habitat conditions. As a part of this project, fencing was installed around the roughly 10-acre restoration site to prevent future degradation of the stream and riparian areas. A hardened crossing was also installed to limit bank trampling while moving livestock between nearby pastures. This fencing component, as well as evidence of this type of restoration are still visible today and have served as an example of a successful small-scale restoration project.

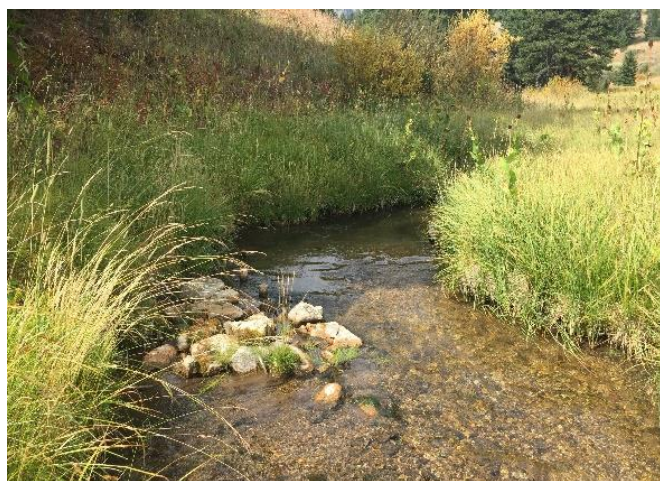
Figure 5: Restoration site on Wigwam Creek.

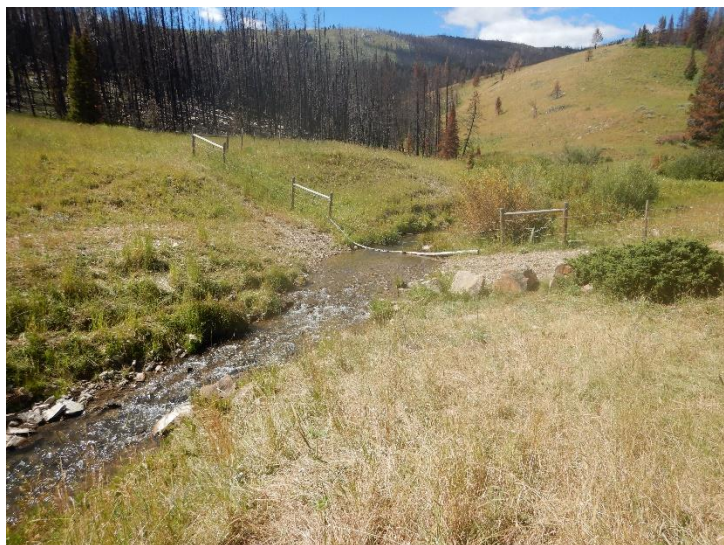
Figure 6: Burn area proximity to Wigwam Creek.

The upper reaches of the North Fork of Wigwam Creek and a roughly 1 mile stretch of Wigwam Creek below the FS Road bridge were within the fire area of the 2018 Wigwam Fire which burned across roughly 6,000 acres of USFS land. Although the riparian corridors along Wigwam, Buffalo, and Arasta Creeks escaped any severe fire effects, forested sections in the upper reaches of the North Fork of Wigwam Creek were burned over leaving standing burned timber adjacent to the riparian area. Although not aesthetically pleasing in the years immediately following the fire,

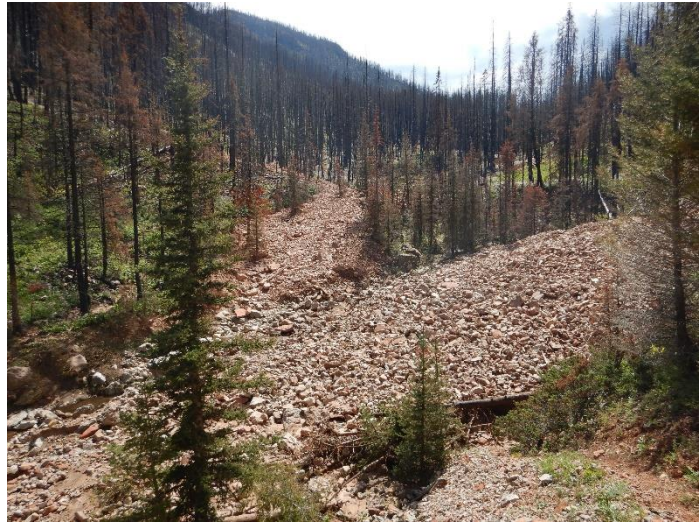
Figure 7: Rock and mud slides within the burn area of the upper Ruby Creek drainage.

During the summer of 2018 most of the Ruby Creek drainage, along with most of its upper tributaries except for Skunk Creek and the South Fork of Ruby Creek, were completely burned over in the lightning caused Monument Fire. The USFS and FWP received reports of heavy sediment flows following significant localized rain events reaching the Madison River at Ruby Creek Fishing Access Site the following summer. USFS fisheries staff surveyed the drainage in 2019 and found substantial hillside erosion of rock and mudslides into the floodplain within the burned areas of the upper drainage. In these upper reaches, Ruby Creek lacks sufficient surface flow to support aquatic life until its confluence with Grindstone Gulch which is outside of the fire area. Any significant amounts of sediment reaching the Madison River was transported through the drainage from these upper reaches. Sediment transport from the fire area following rain events will be an ongoing concern as downstream effects to WCT occupied habitat could accumulate.

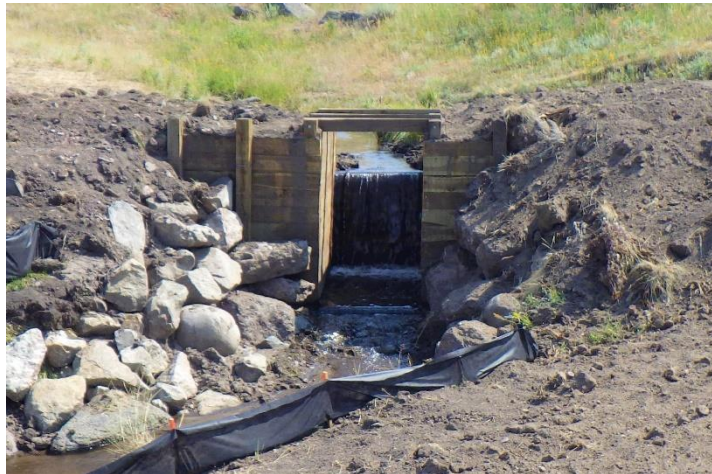
Figure 9: English George Creek wood barrier.

Just south of Hyde Creek, English George Creek also originates on USFS land and runs through the Wall Creek game management area before reaching the Madison River. Roughly 5 miles of English George Creek is protected by a barrier that was installed in 2017 near the Lower Wall Creek Game Range Road crossing which has secured a 93% genetically pure population of WCT (FWP Fishing Guide Mapper, 2021). English George Creek has served as a model for future construction in the Madison River watershed of the more affordable wooden barrier structures.

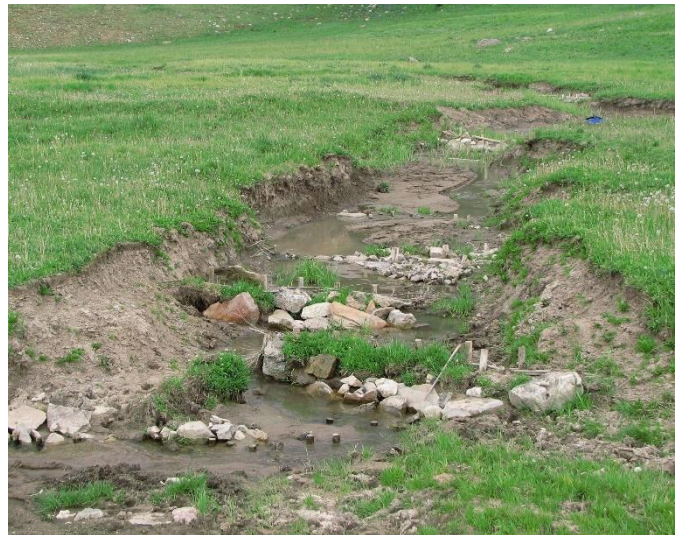
Figure 10: Horse Creek baffle installation in 2006.

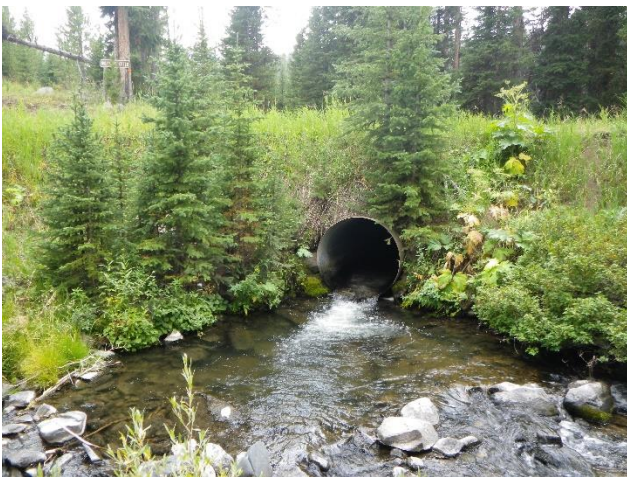
Figure 22: Wolverine Creek culvert on USFS Road 237.

USFS Road 237, which runs along Standard Creek from the West Fork Madison Road and up to the Gravelly Range Road, provides one of the few public access points to reach the South Gravelly Range. Although the road only crosses Standard Creek at one location in the headwater reaches and is not of concern to impairments in water quality or aquatic organism passage, the culvert crossing of Wolverine Creek near its confluence with Standard Creek is partially perched but likely not impeding aquatic organism passage at this time.

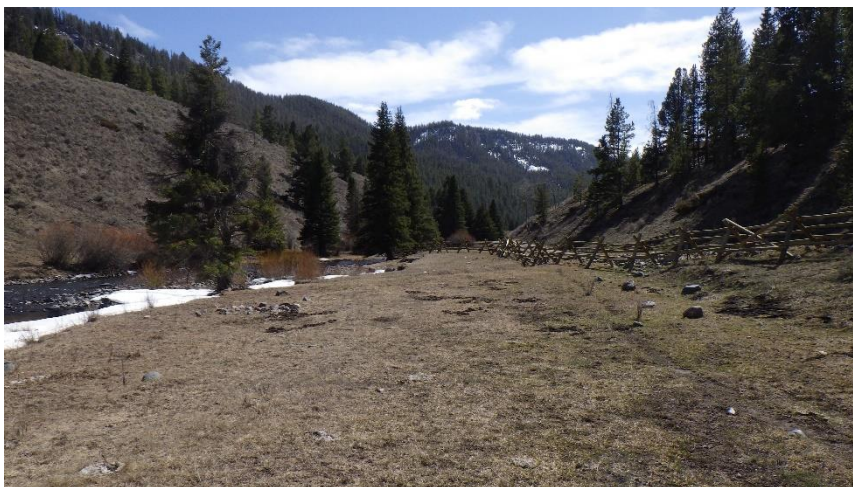
Figure 23: 2014 Fencing project area on Lower West Fork Madison River.

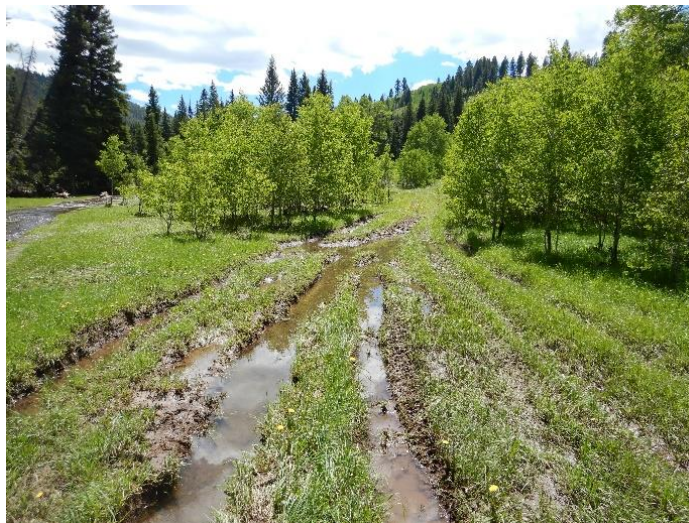
Figure 25: Wheel ruts adjacent to the West Fork Madison River at a Recreational Site.

Similar to grazing impacts, the concentrated recreational use in the lower West Fork Madison River is causing changes to streamside riparian habitat as well as streambank erosion at several sites. Recommendations to mitigate recreational and motorized use impacts include improvements and reinforcement to stream banks in high use areas, reestablishment of riparian grasses and willows to exposed banks to limit excess sedimentation and siltation, riparian fencing to exclude livestock and to limit recreational impacts where applicable, as well as moving dispersed camping sites away from the stream corridor (recommend ≥ 30 ft). Monitoring and management of frequently used recreational sites, including seasonal closures of sites or those that are already severely degraded will be critical to improving future conditions. Coordination with USFS Range, Recreation, and Fisheries staff will be an important component to implementing future improvements on the lower West Fork Madison River.

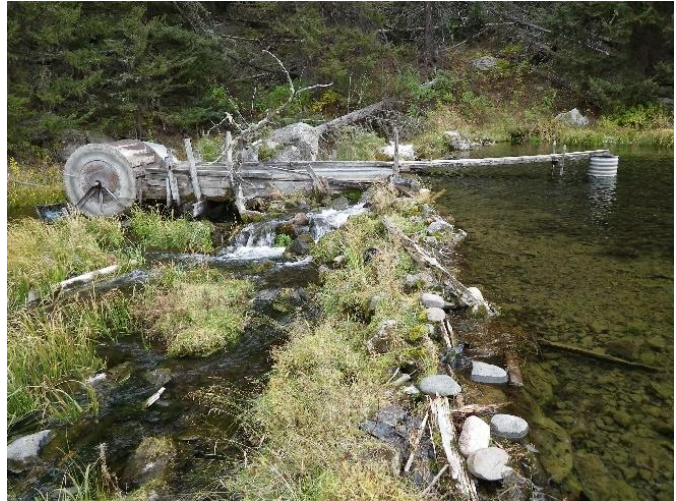
Figure 26: Smith Lake dam and water wheel.

The headwaters of the Lake Creek sub-watershed originate from a hillside spring source at the divide separating Wade Lake from the West Fork Madison River watershed, running for roughly 2 miles before its confluence with the West Fork Madison. Just before reaching the confluence, Lake Creek forms the 5 acre Smith Lake which was historically created with an earthen dam by irrigators and agricultural users as a site for a water wheel pump which was used to transport water to stock tanks located on an elevated bench to the east (Lohrenz, Comm. 2021). Remnants of the water wheel and the earthen dam are still present at the site today, although the earthen dam is not an identified fish passage barrier. A fish ladder was installed in 2015 by FWP and USFS Fisheries staff to aide in the upstream migration of fish into the lake and the productive upstream spawning reaches of Lake Creek.

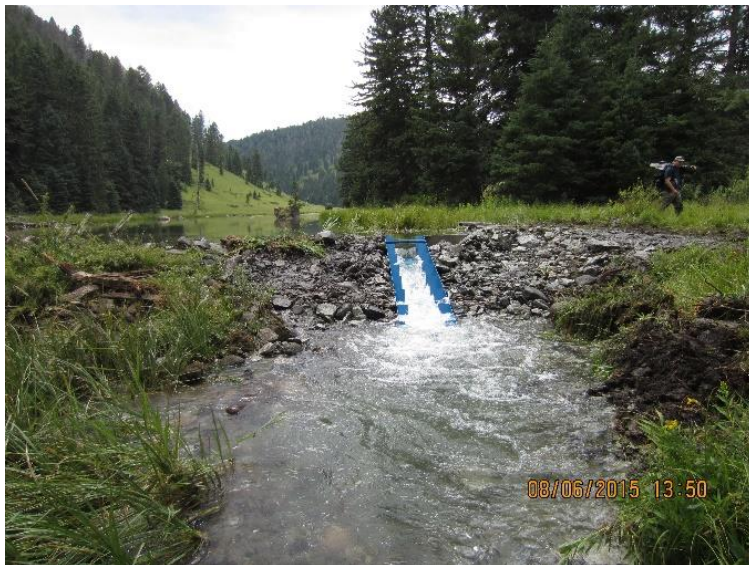
Figure 27: Smith Lake fish ladder.

With overall stream conditions being near pristine, recommendations to improve current conditions are limited. Maintaining a functioning fish ladder at Smith Lake will be critical in continuing to allow the passage of fish into the upper spawning and rearing habitat of Lake Creek. Ongoing monitoring of the LL population and overall stream condition should also continue to ensure persistence of this population into the future.

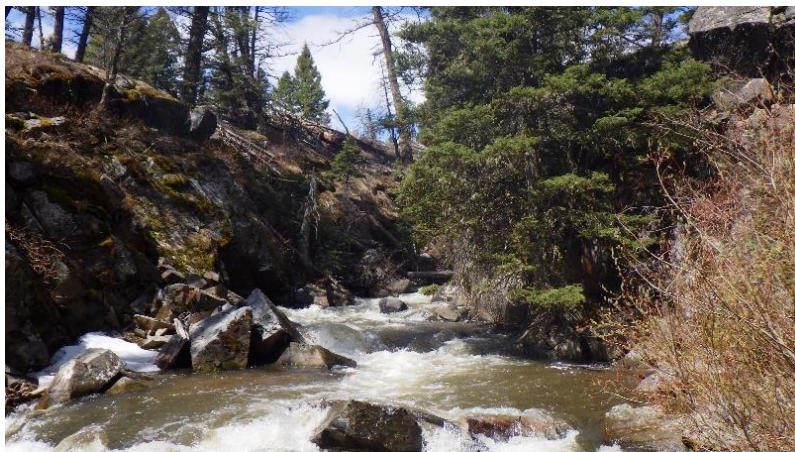
Figure 28: Elk River identified barrier site.

Although currently occupied by an abundant population of mostly hybrid WCTxRBT, Elk River and its tributaries have been identified by FWP, the USFS, and MADTAC partners as being a future major project area for Westslope Cutthroat trout restoration in the Madison River watershed. A barrier site in the lower reaches within a steep canyon has already been identified, as well as the required design and

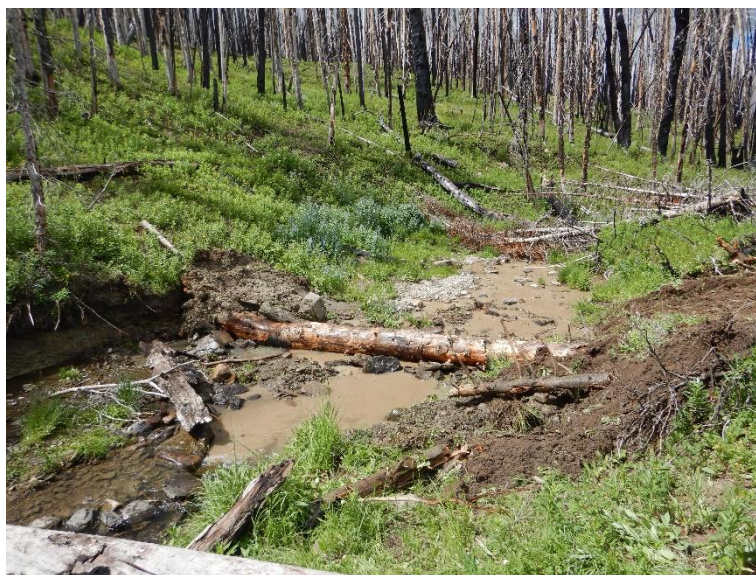
Figure 29: Installation of pool habitat in Upper West Fork Madison.

Upstream of the fenced section on the West Fork Madison is the confluence with Fox Creek, after which the West Fork continues to its headwaters which originate near the USFS West Fork Cabin in Eureka Basin. The area around Fox Creek and the headwaters of the West Fork Madison were within the 8,000-acre Eureka Basin Fire of 2013. Island stands of burned timber adjacent to the upper West Fork Madison are still evident today although the fire never reached the riparian corridor along the stream. In 2019 an effort led by USFS Fisheries staff and funded by MADTAC was undertaken to create overwintering pool habitat by strategically placing burned trees into the channel for a population of conservation WCT in a reach of the upper West Fork immediately downstream of the USFS cabin. Several pool structures were created as well as stabilization of eroding streambanks and modifications to over widened sections of stream

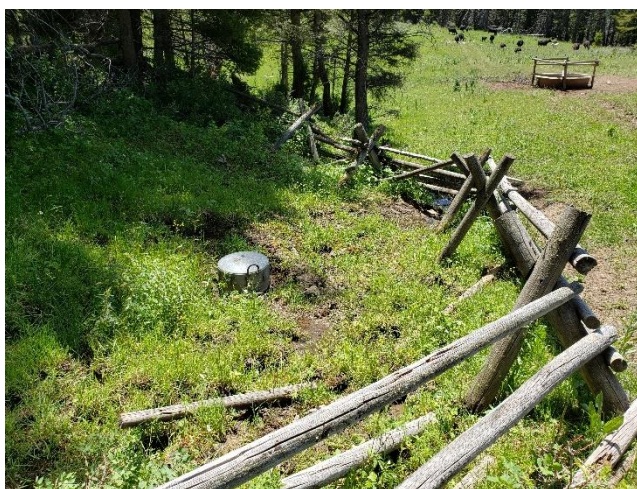
Figure 30: Example of a fenced-out spring development and trough system.

Further upstream on the West Fork Madison at the confluence with Portal Creek, a roughly one-mile section of the West Fork that is highly accessible to livestock has been degraded through historic and current grazing practices. Riparian vegetation is lacking throughout and there is evidence of livestock congregating and accessing the river at various locations leading to sections of bank disturbance and stream channel widening. Although this location on the landscape may be conducive to livestock access, it does provide an opportunity to install exclusion fencing around the degraded section of river due to the lack

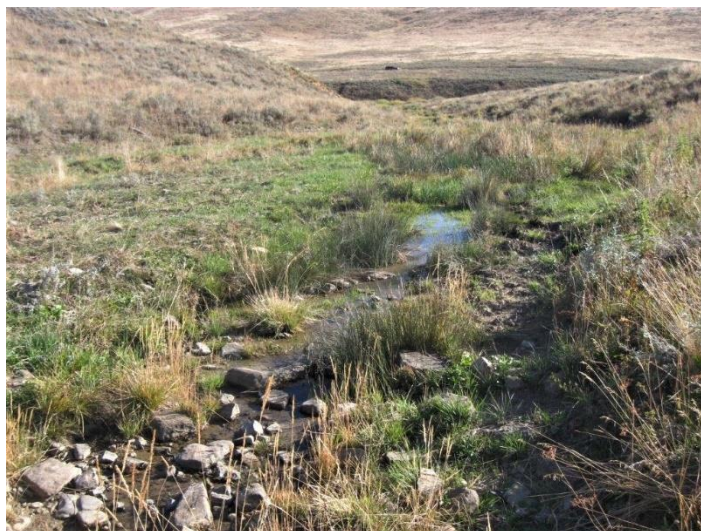
Figure 31: Degraded and over widened section of Anderson Creek.

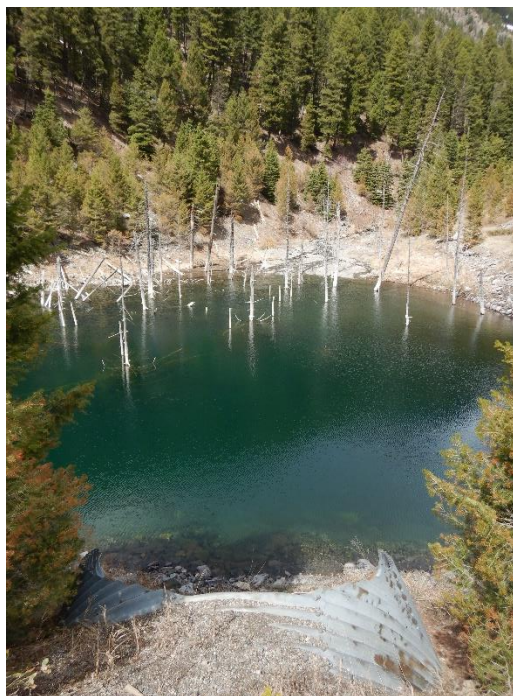
Figure 34: Rock Creek pond at MT Highway 287 culvert crossing.

Rock Creek is a roughly 2-mile-long stream that originates at 8,950 feet at Brownie Lake and ends at its confluence with Quake Lake at 6,400 feet. This extremely steep drainage runs between two mountain hillsides with scree slopes on either side creating a narrow riparian and stream corridor lacking suitable fish habitat. Brownie Lake is a small, high-alpine snowmelt lake that is connected to several small ponds and wetlands. Brownie Lake appears to be the only lake with sufficient depth and size to fish but has not been sampled as part of the Mountain Lake Fisheries Status Report. No fish were caught when sampling the lower reaches of the creek (Lohrenz, Comm. 2021). Rock Creek flows into a roughly 2-acre pond created by MT highway 287 that is relieved by a perched culvert into Quake Lake.

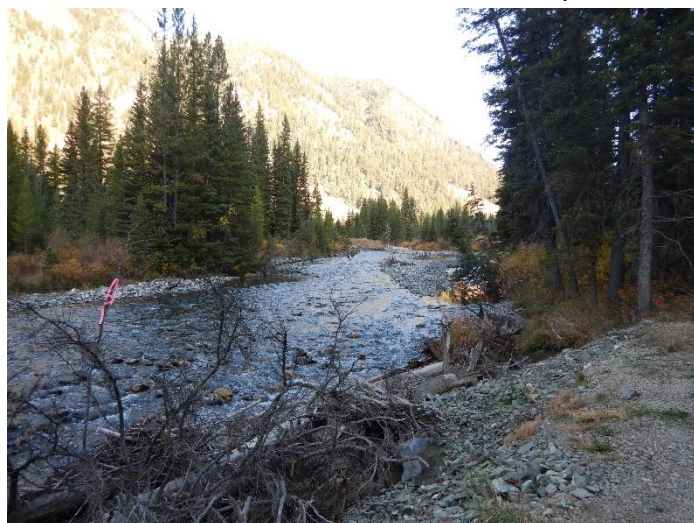
Figure 36: Eroding road segment along Lower Beaver Creek.

Although a large portion of this watershed is within Wilderness, several lower portions of Beaver Creek could benefit from management actions to improve current conditions. Some of these actions include reinforcing sections of streambank where the road is actively eroding into the stream to decrease excess sediment inputs as well as creating a management plan for the

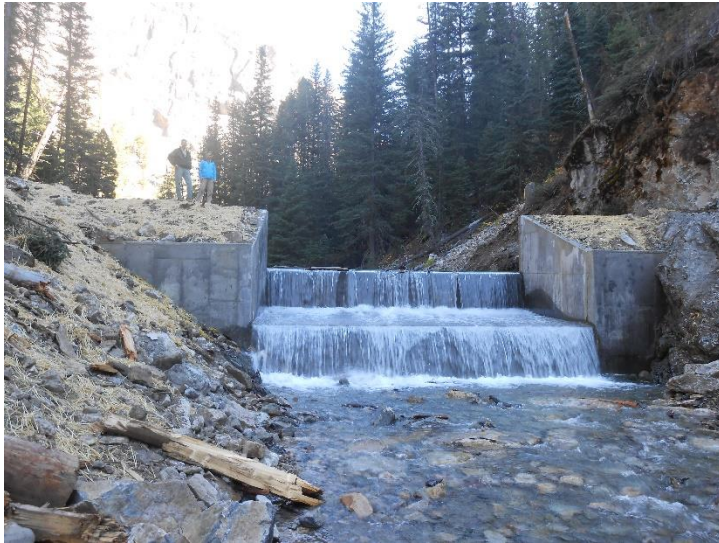
Figure 38: Cabin Creek Barrier.

protection of native fish into the future (Custer-Gallatin Forest Plan, Appendix C, 2020). This critical watershed located just downstream of Hebgen Dam is home to one of the few WCT strongholds on the Madison River. With the construction of a fish passage barrier in 2015, roughly 18 miles of habitat have been secured for an existing population of 97% pure WCT (FWP Fishing Guide Mapper, 2021). Before the barrier was constructed, a waterfall feature located roughly .75 miles upstream from the mouth had begun to allow non-native RBT to ascend into the

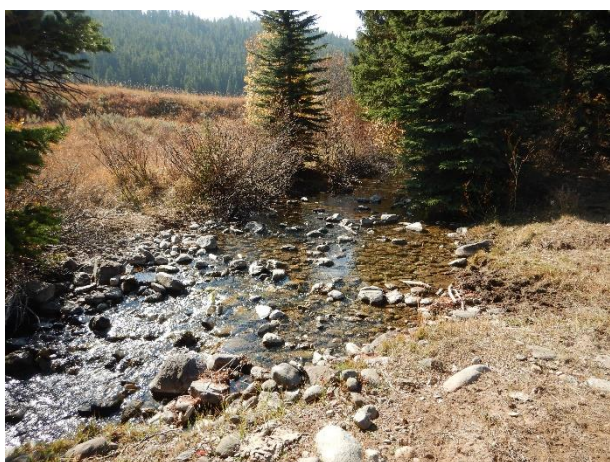
Figure 40: Livestock impacted crossing on lower Watkins Creek.

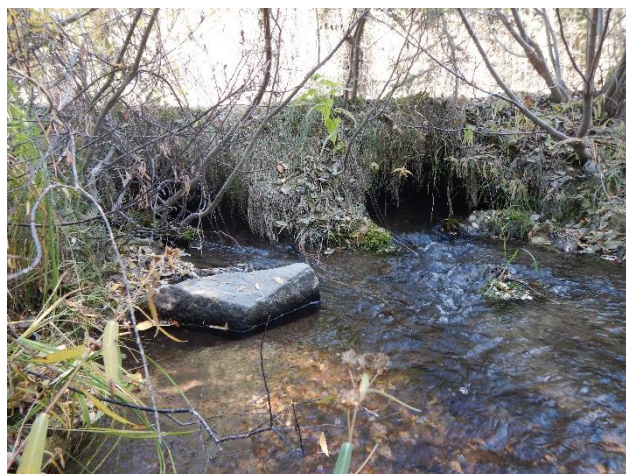
Figure 41: Two culvert system on Rumbaugh Creek.

Several miles south of Watkins Creek along Denny Creek Rd. is Rumbaugh Creek. This short, roughly 2-mile system flows through steep forested terrain, through a potentially undersized side-by-side culvert under Denny Creek Rd and out to Hebgen Lake. Historic sampling data shows resident LL and RBTxCT hybrids occupying the stream, but abundances are limited. Baseflow in the lower reaches is estimated to be roughly 3-4cfs, but the stream does have connectivity with Hebgen Lake allowing fish to migrate into the system during spawning season to access the lower 1.5 miles of suitable habitat.

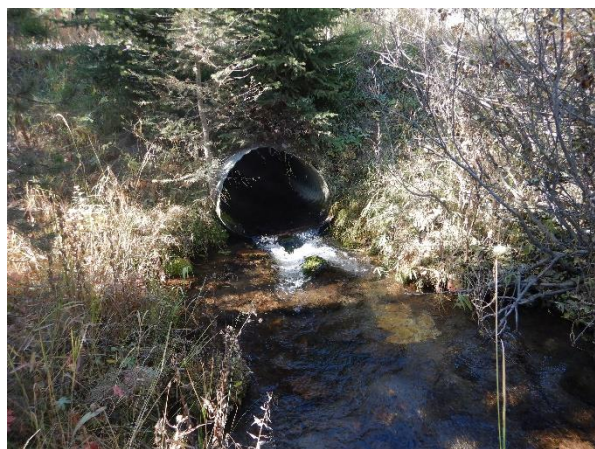
Figure 42: Downstream culvert on Cherry Creek.

Finally, the stream system farthest south in this sub-watershed is Cherry Creek. This stream originates in the hillsides above Hebgen Lake and flows for roughly 1.5 miles adjacent to a recent timber project area, into a culvert crossing under Denny Creek Rd. and through a USFS campground before the channel becomes braided into a large pond and wetland area connected to Hebgen Lake. Streamside mitigation zone setbacks and practices appear to have been followed in sections of stream adjacent to the timber/fuels project area. The downstream end of the culvert under Denny Creek Rd. appears to be slightly perched during baseflows, but the culvert is appropriately sized for its location and ability to handle higher flows. No historic or current fish sampling data exists on this stream, but field investigations and GIS analysis indicate that connectivity to Hebgen Lake may be limited due to the complexity of the pond and wetland complex in the lowest reaches.

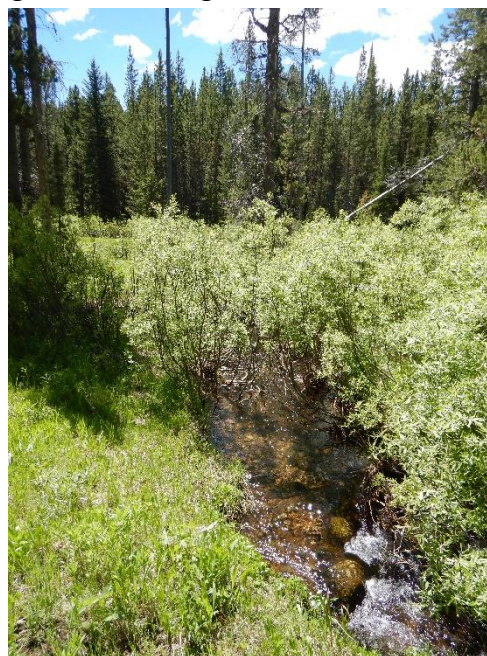
Figure 47: East Fork Cream Creek streamside habitat.

Like the West Fork of Cream Creek, the East Fork of Cream Creek has also seen extensive logging throughout most of the drainage with past logging also occurring within the streamside corridor. However, East Fork Cream Creek is a perennial system with a conifer and willow dominant riparian corridor throughout with LWD abundant for future recruitment. Past sampling efforts show RBT, LL, and RBTxWCT hybrids are present throughout (FWP Fishing Guide Mapper, 2021). Used primarily by OHV recreationalists as an access route to the connected trail network, USFS Road 987 has one culvert crossing and does parallel the stream for most of its entirety on USFS land. There is some concern of excess sediment delivery into the stream from this road due to its proximity to the stream. Even with the amount of past logging that has occurred in this drainage, the stream does have the characteristics of a functioning system in desired condition given the amount of time the system has been given to recover. The lowest reaches of the East Fork of Cream Creek at the confluence with the West Fork of Cream Creek and the short stretch of Cream Creek proper before joining with the South Fork Madison River are all within sections of private land.

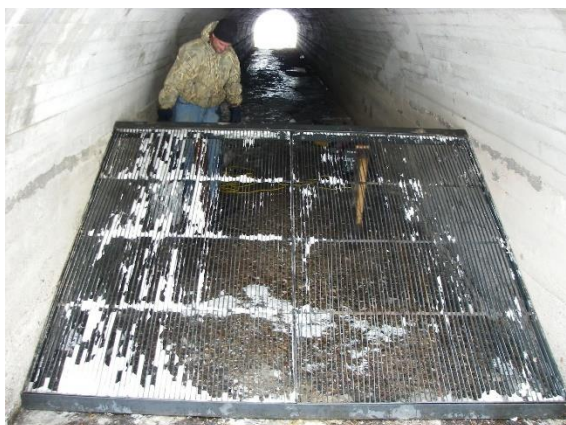
Figure 48: Weir-like metal fish passage barrier grate installed into tunnel in 2007.

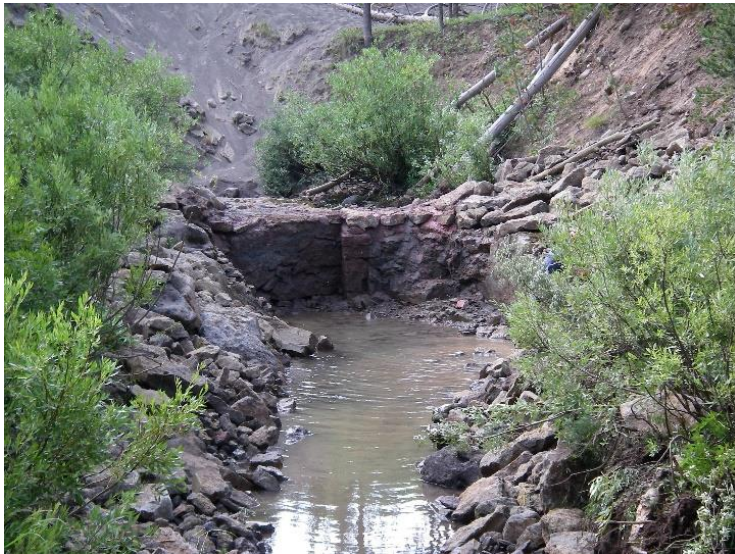
Figure 49: Improved barrier structure on the Upper South Fork Madison

With the channel dry for 3.5 miles below the USFS Road 1704 crossing, a 95% pure population of WCT has managed to persist in the uppermost reaches above this crossing where there is sufficient perennial flow (FWP Fishing Guide Mapper, 2021). So far, two projects have been undertaken by USFS Fisheries Staff and FWP to protect this population from invasion by downstream nonnatives and further genetic introgression. In 2007, a weir-like metal grate was installed at the inlet to the tunnel running under the railroad crossing just upstream from Mosquito Gulch to prevent fish passage during high flows. During the following years runoff, the grate became clogged with debris creating a large upstream pool that began to jeopardize the integrity of the century old railroad grade. In 2008, explosives, an excavator, a cement mixer, and hand work were used to improve a waterfall feature just downstream from where the sub-surface flow surfaces again, just downstream from the railroad grade crossing. Although an improvement from the weir-like metal grate system, there is still doubt as to the effectiveness of this improved structure during higher flows and due to the presence of redds discovered in the reach above the barrier (Sestrich, Comm., 2021).
