# THE STATE OF THE STREAMS

**Maia Schweikert, Natural Resource Specialist**  
**Ennis, Montana - June 2026**

Madison Conservation District

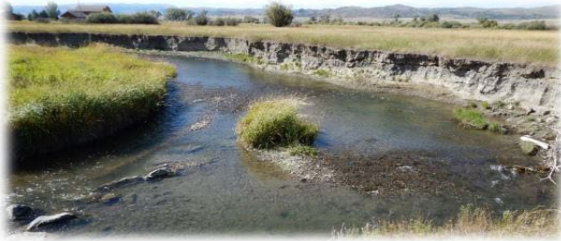
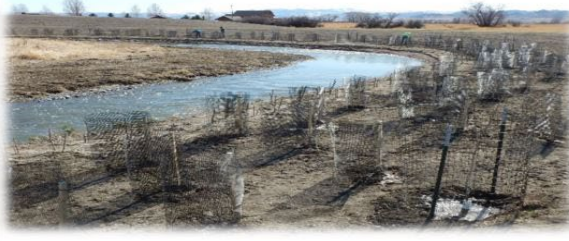
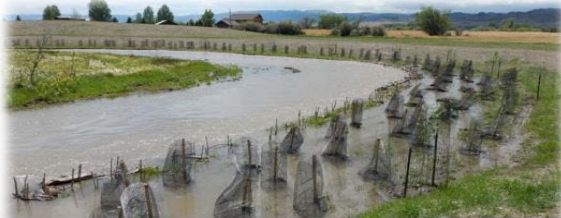
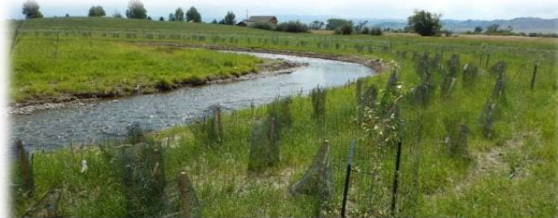
*Figure 11: Large bend on part of Lower Jack Creek Restoration. Note the spillover of high water onto banks that soaked into the riparian area and provided water for soil recharge and establishing plants during the project's first year.*

The primary goal of Lower Jack Creek Riparian Restoration Project was to install treatments that provide habitat improvements and to stabilize eroding, historically altered streambanks. To achieve this goal, the treatments incorporated design materials that were appropriate for the site and able to withstand the variable flows of this high energy system. The Madison Conservation District completed this project in partnership with Trout Unlimited, Trout and Salmon Foundation, Northwestern Energy, Montana Watershed Coordination Council, R.E. Miller and Sons, Montana Conservation Corps, Montana DNRC, and Montana Fish, Wildlife and Parks (FWP). It would not have been possible without the landowners, The Madison Valley Ranch and Fasules Family.

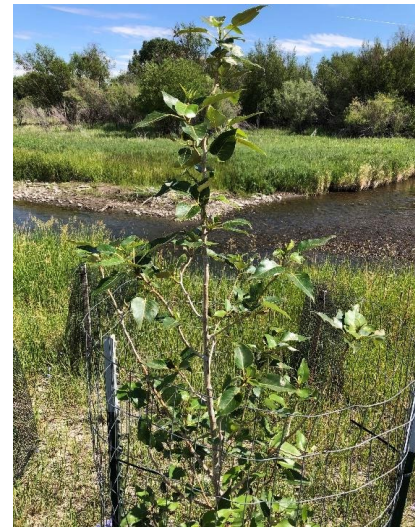
*Figure 12: Cottonwood planting from 2020 at the Lower Jack Creek Restoration in 2021*

The final planting of the Lower Jack Creek restoration project was completed in 2020, after several years of engineering. In 2021 regular monitoring and watering of the site was done to ensure successful establishment of the cottonwood and willow plantings. Every cottonwood planted in 2020 has survived, and watering will continue if drought persists. Due to extreme drought and low flows, many of the willow cuttings had difficulty accessing water and had a low success rate.

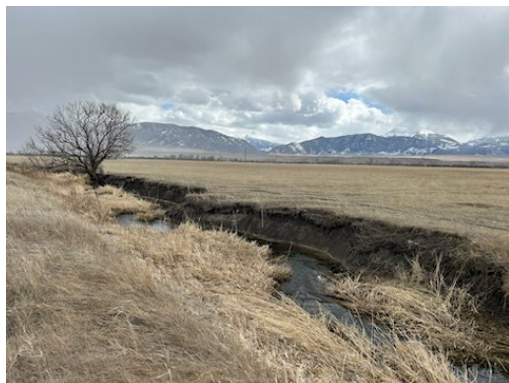
*Figure 13: Straightened and Incised Section of Moore Creek Pre-Restoration*

Originating in the southeastern flanks of the Tobacco Roots Mountain Range, Moore Creek collects a number of smaller tributaries in its descent towards the Town of Ennis. The creek is colloquially known as “Poop Creek” given its 150-year history of Europeans settling and establishing along its banks. This name has proven to be representative of recent conditions as Moore Creek was listed as impaired for E. Coli from both human and cattle. In addition to E.

The Lower Moore Creek restoration project seeks to restore degraded and historically channelized conditions on a segment of lower Moore Creek near the confluence with the Madison River (Ennis Lake/Res.). The project aims to improve instream and riparian wildlife habitat by enhancing water quality and restoring riparian and wetland vegetation. It will also reduce sediment inputs by stabilizing eroding banks and preventing further stream incision and erosion.

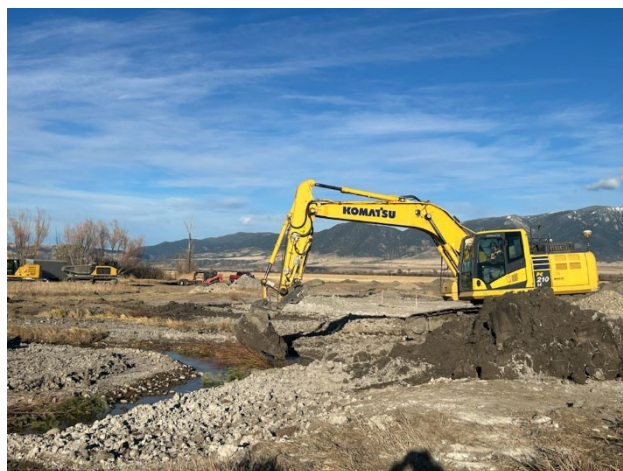
*Figure 14: Construction of New Moore Creek Stream Channel*

This comprehensive project will unfold in multiple phases over the coming years and will incorporate several agencies, organizations and landowners. Phase 1 of the Moore Creek project began in winter of 2024. Thus far, this phase comprised approximately a 0.3 mile section of Moore Creek that was straightened, incised, and devoid of woody vegetation. The restoration plan involved the construction of 0.53 mile of new stream channel and floodplain features with a focus on: a.) restoring eroding streambanks; b.) re-establishing channel cross-sections dimensions, plan form and longitudinal profile dimensions; and c.) increasing floodplain connectivity. Project completion also resulted in the restoration of approximately 6 acres of previously drained wetland area. This phase also included passive restoration efforts, such as implementing riparian fencing, hardened crossings, and water gaps to protect sensitive riparian areas and vegetation.
